**NL INDUSTRIES/TARACORP SUPERFUND SITE GROUP**  
**2209 Quarry Drive, Suite C-35**  
**Reading, PA 19609**  
**Telephone: (610) 670-7310**  
**Facsimile: (610) 670-7311**

December 1, 2020

**Re: NL Industries/Taracorp Superfund Site; Granite City, Illinois**  
**Second 2020 Semi-Annual Operation and Maintenance Inspection (November 9, 2020)**  
**Annual Site Visit (November 10, 2020)**

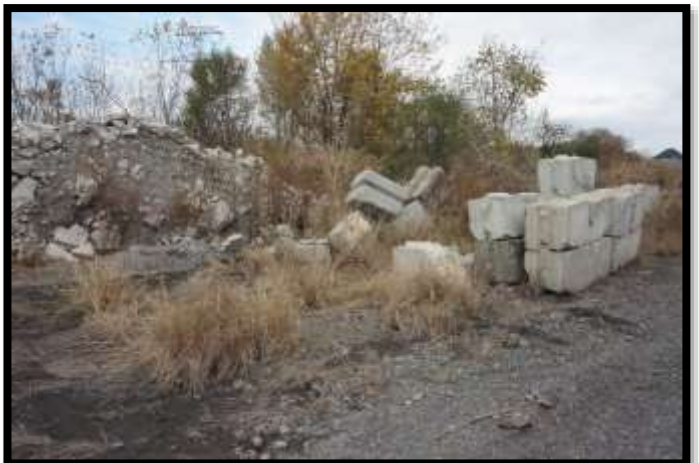
Photograph 6: Slough Road, concrete debris.

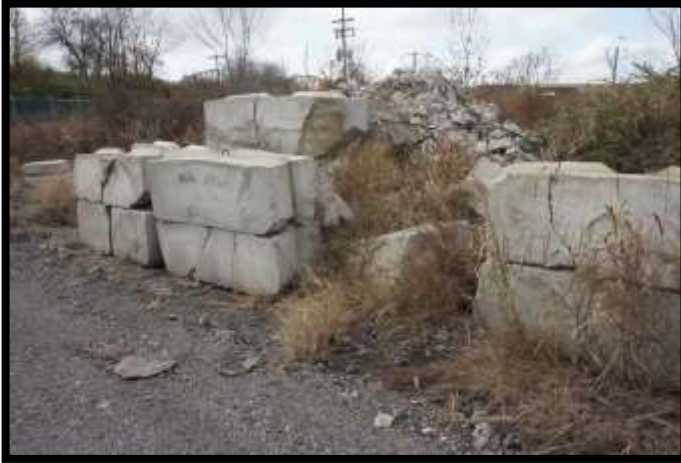
Photograph 7: Slough Road, concrete debris.

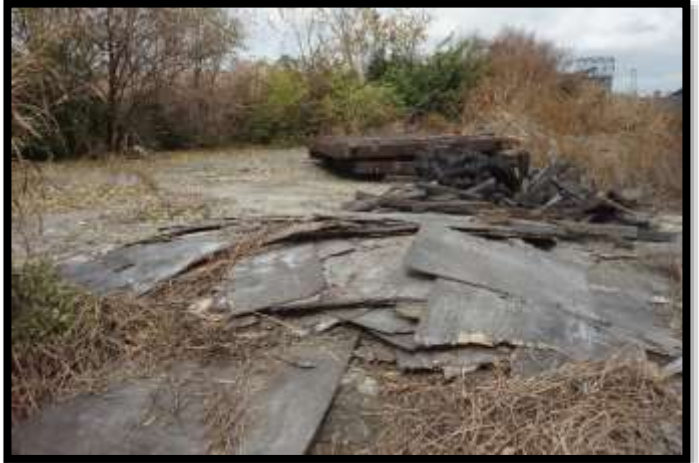
Photograph 8: Slough Road, concrete foundation of former Robin's Nest lounge.

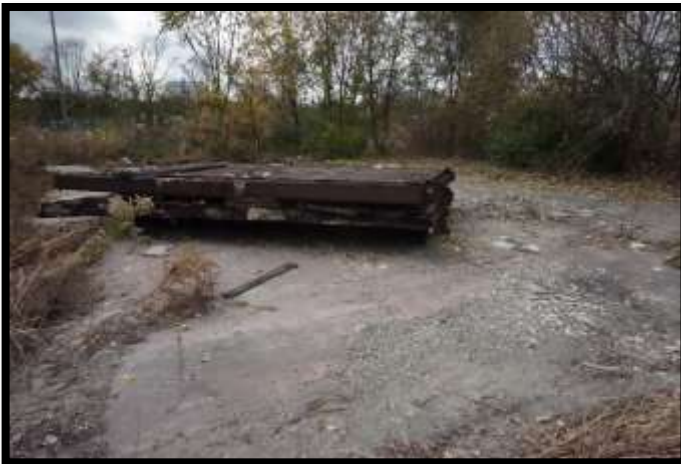
Photograph 9: Slough Road, concrete foundation of former Robin's Nest lounge.

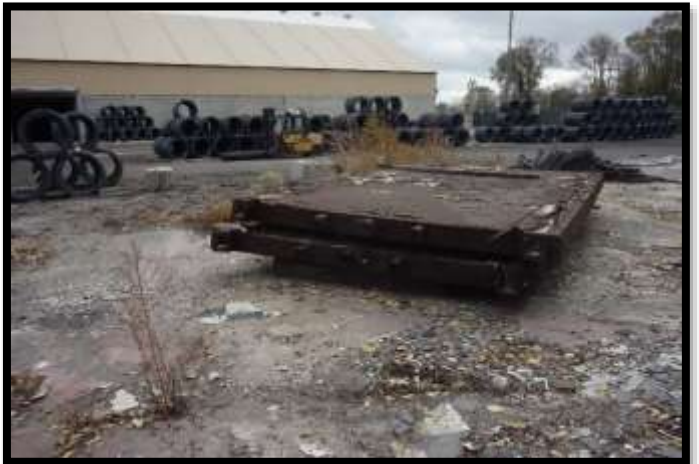
Photograph 10: Slough Road, concrete foundation of former Robin's Nest lounge.

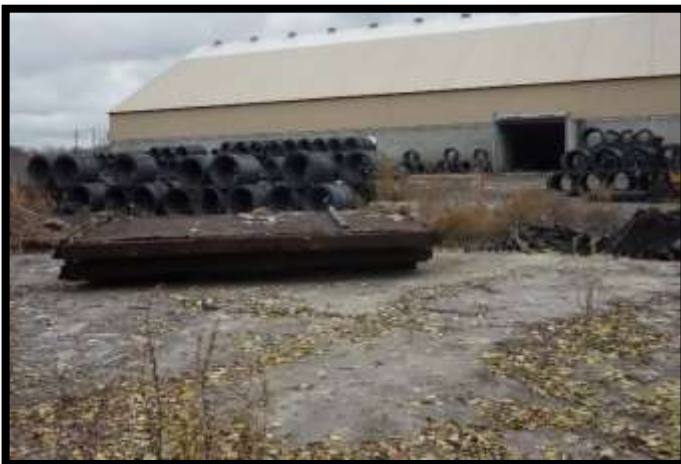
Photograph 11: Slough Road, concrete foundation of former Robin's Nest Lounge.

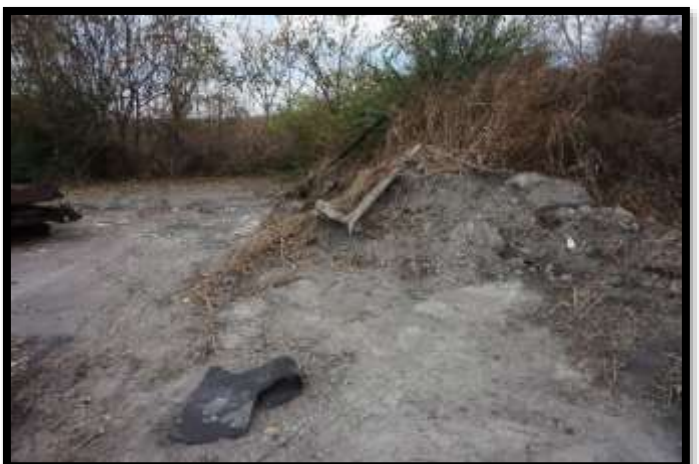
Photograph 12: Slough Road, soil pile.

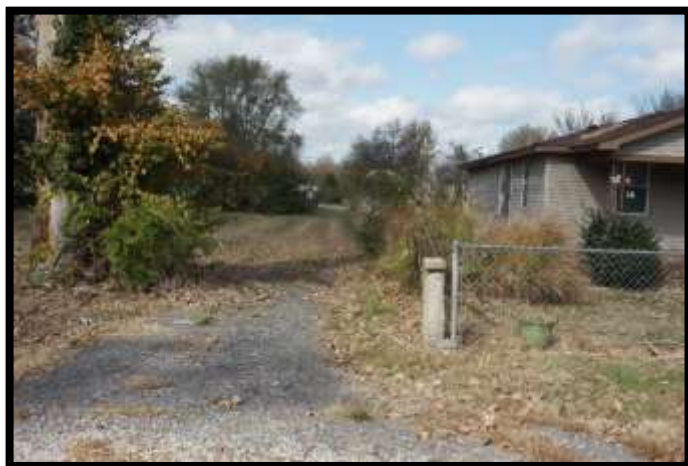
Photograph 3: Watson Alley, gravel area (view from Harrison Street).

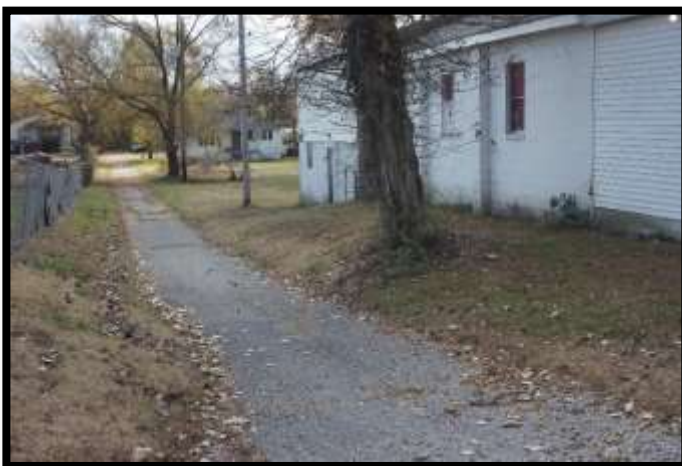
- The paved portion of Watson Alley in Eagle Park Acres (shown on Figure 2 and the photographs in Attachment 2) was inspected. No disturbance to the paved surface of the alley was evident, and the alley is in good condition.

Photograph 4: Watson Alley, paved area (view from Harrison Street).

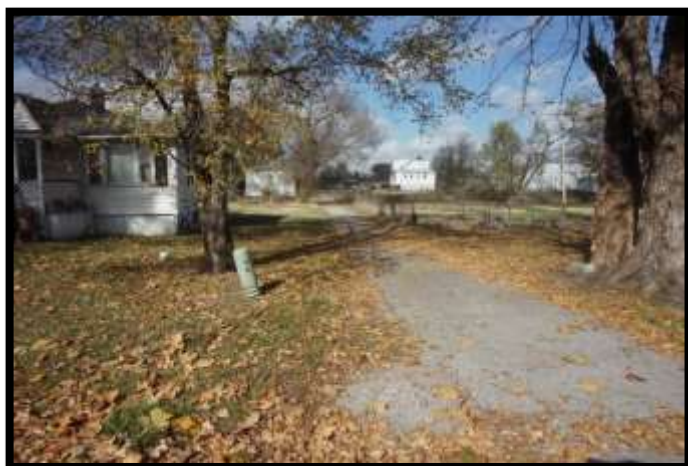
Photograph 5: Watson Alley, paved area (view from Watson Street).

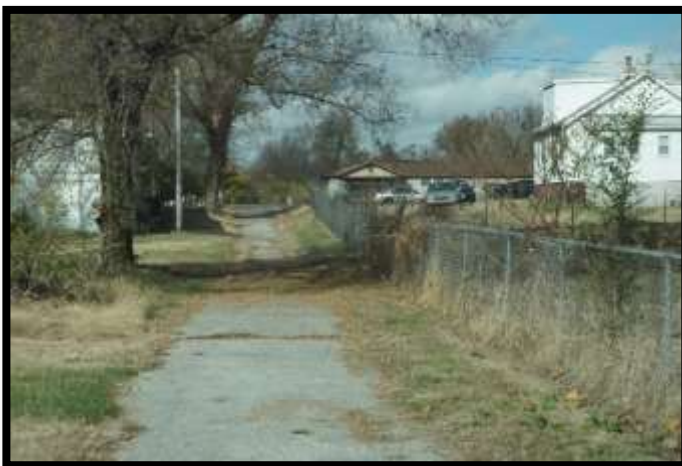
Photograph 6: Watson Alley, paved alley between Harrison Street and Watson Street.

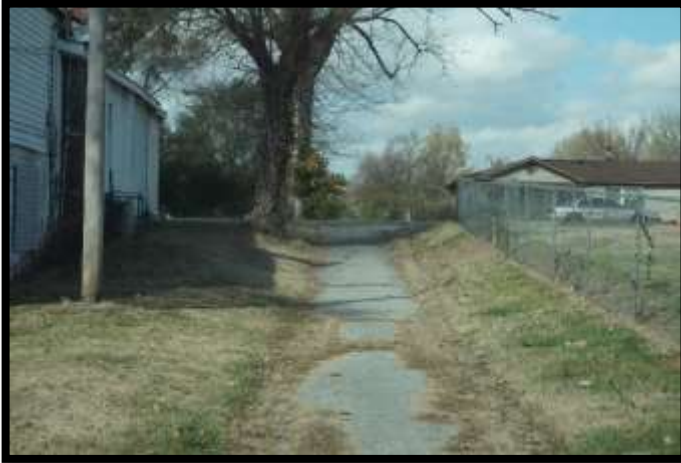
Photograph 7: Watson Alley, paved alley between Harrison Street and Watson Street.

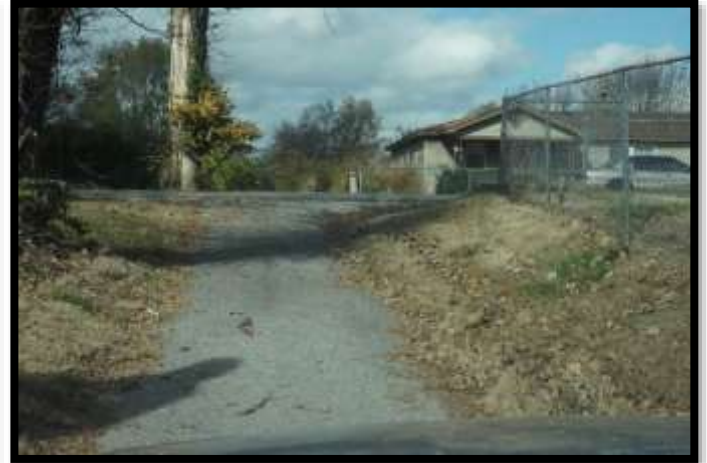
Photograph 8: Watson Alley, paved alley between Harrison Street and Watson Street.

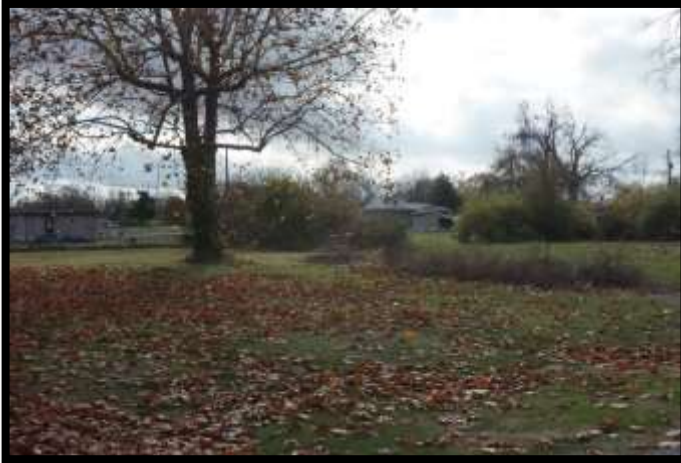
4. Two remote fill properties (200 Allen Street and 206 Terry Street) in Eagle Park Acres (Figure 3) that were previously remediated by EPA (and where lead-impacted soil and/or battery case chips may remain in place at a depth of 3 feet below ground surface) were observed during the inspection. As shown on the photographs in Attachment 3, the properties are vacant, vegetated, and no evidence of subsurface soil disturbance was observed.
5. The Harrison Street property where some scattered battery case chips were first observed in May 2019 was checked during the inspection. As shown on the photographs in Attachment 3, the property is vacant, vegetated (and recently mowed), and no evidence of subsurface soil disturbance was observed.

Photograph 1: 206 Terry Street property.

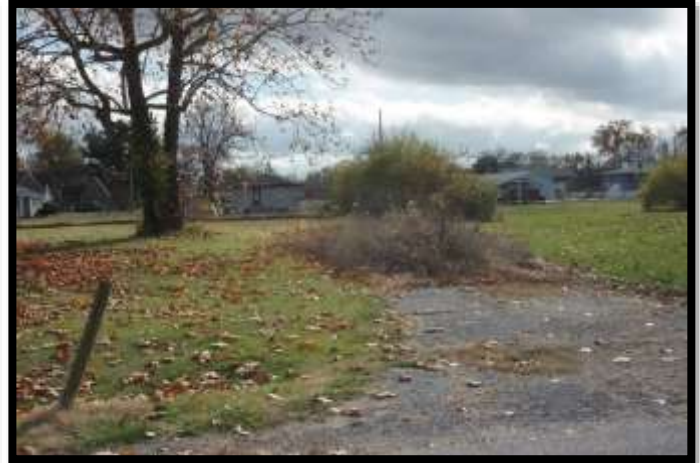
Photograph 2: 206 Terry Street property.

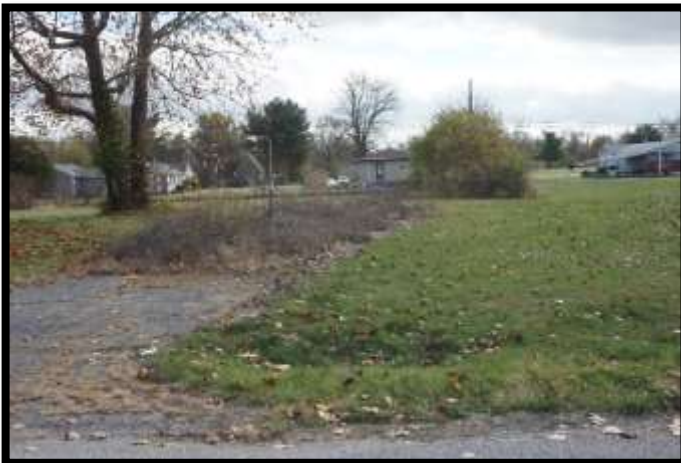
Photograph 3: 206 Terry Street property.

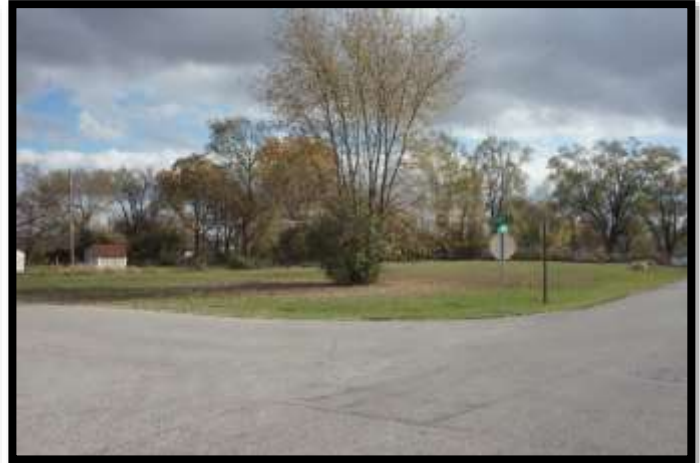
Photograph 4: 200 Allen Street property.

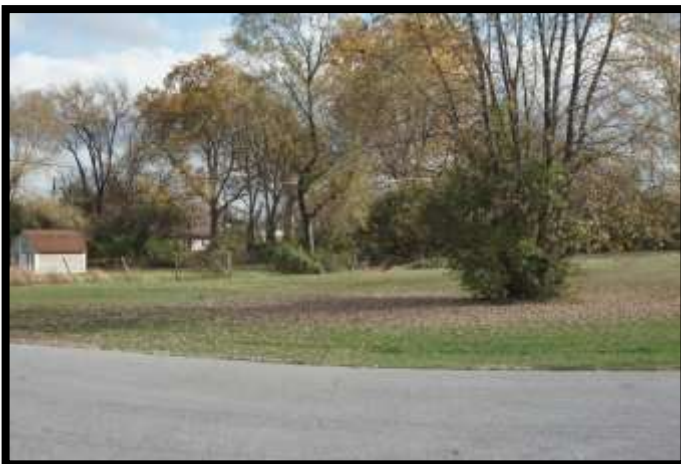
Photograph 5: 200 Allen Street property.

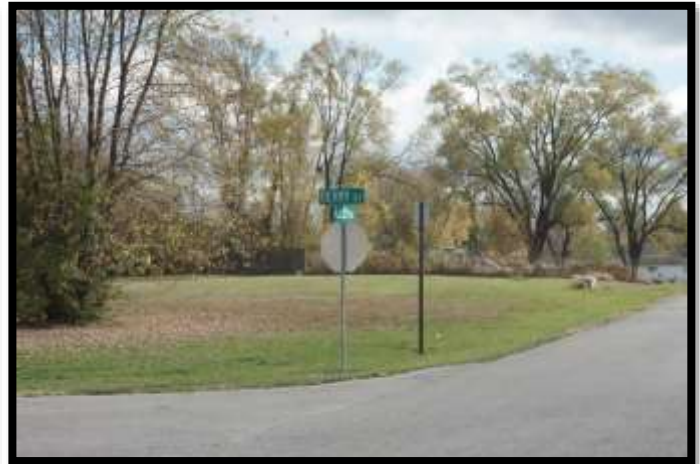
Photograph 6: 200 Allen Street property.

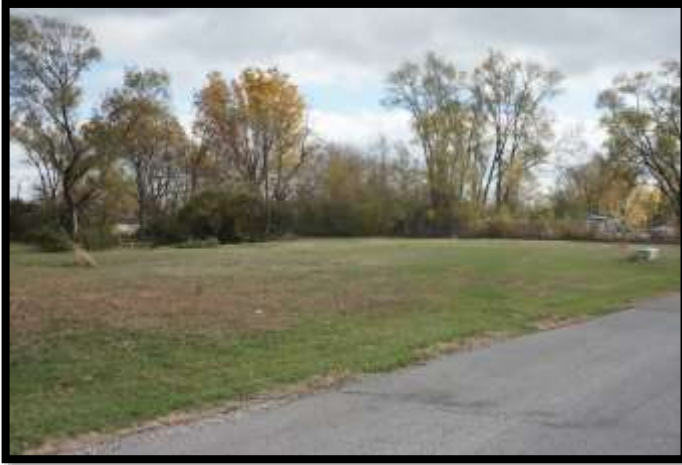
Photograph 7: 200 Allen Street property.

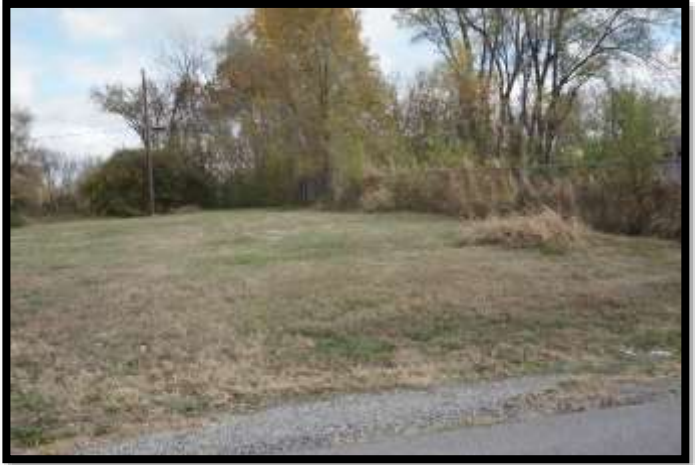
Photograph 8: 200 Allen Street property.

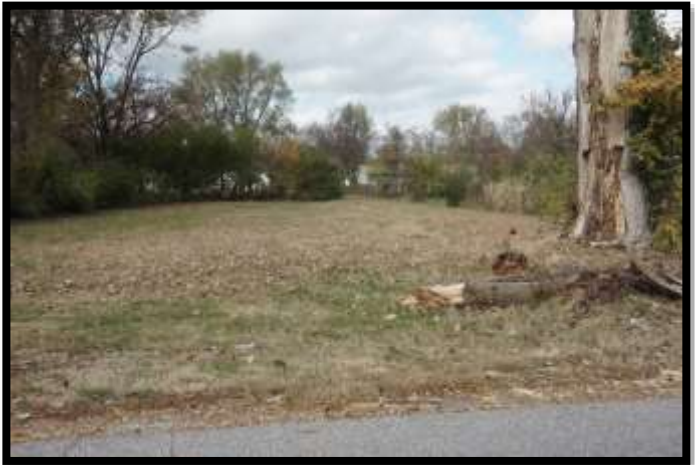
Photograph 9: Harrison Street property (vegetation recently cleared).

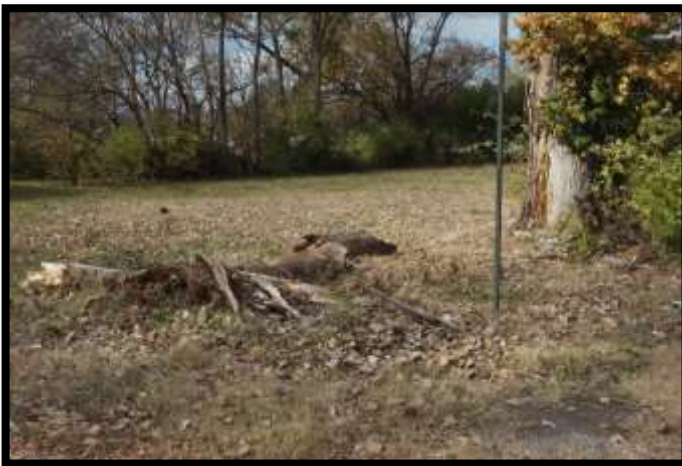
Photograph 10: Harrison Street property (vegetation recently cleared).

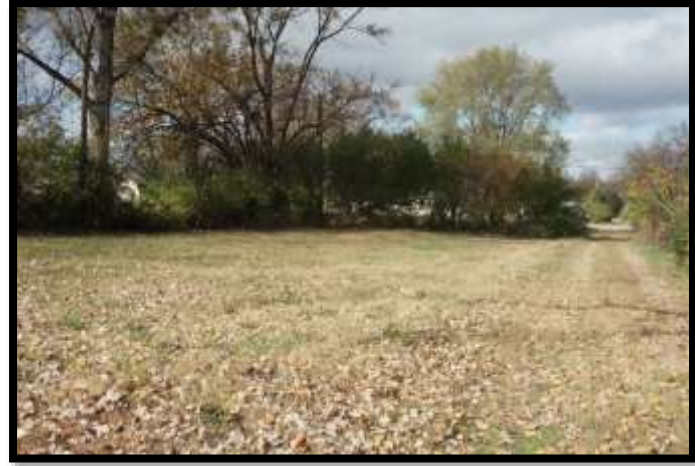
Photograph 11: Harrison Street property (vegetation recently cleared).

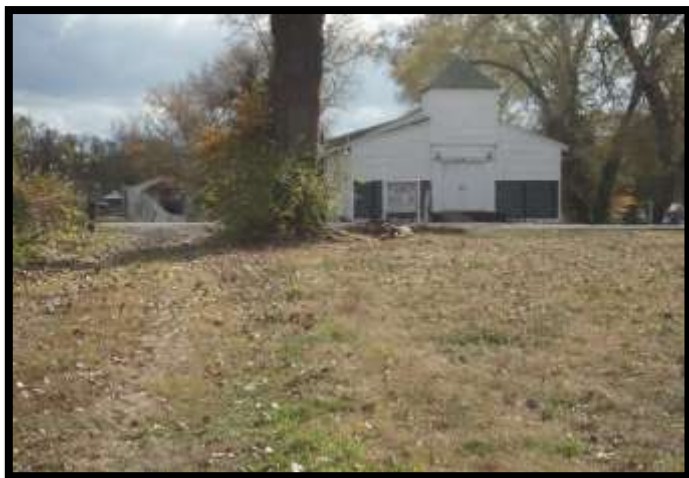
Photograph 12: Harrison Street property (vegetation recently cleared).

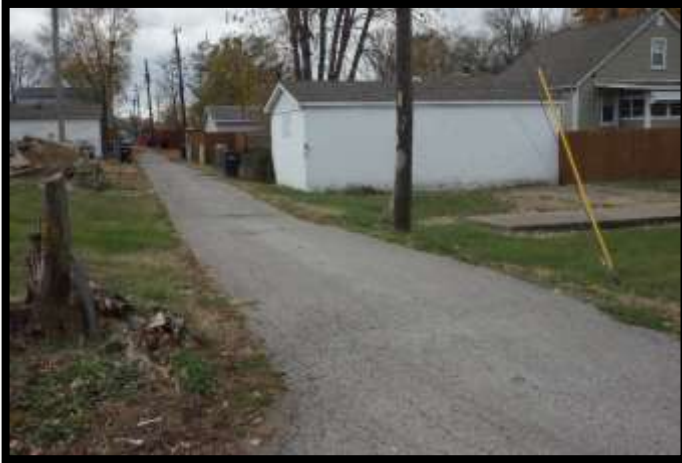
Photograph 1: Alley at McKinley Street near Broadway.

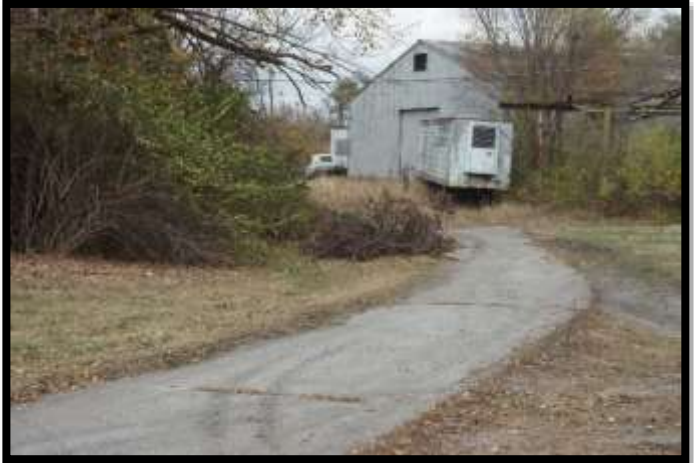
Photograph 2: Alley at McKinley Street and Brown Street (view north).

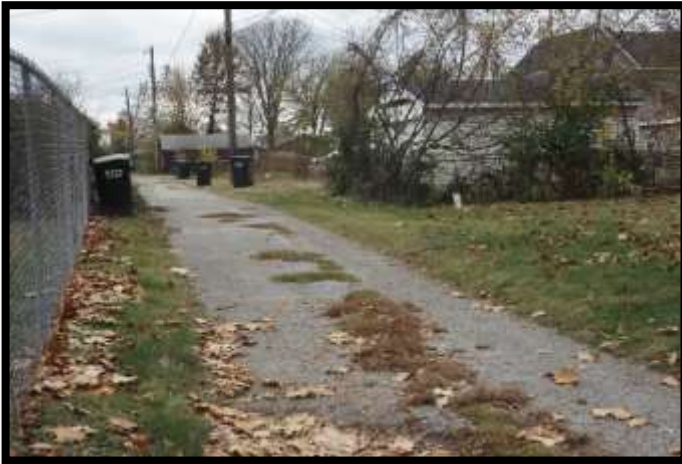
Photograph 3: Alley between Robin Street and Oriole Street (view south).

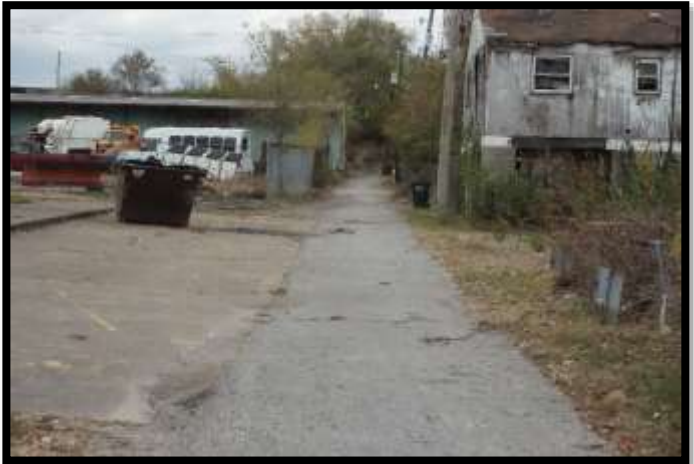
Photograph 4: Alley between Oriole Street and Klein Avenue (view north).

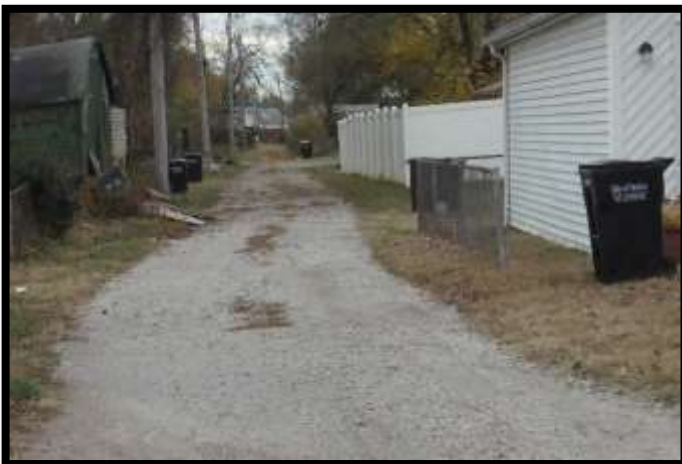
Photograph 5: Alley (gravel) between Oriole Street and Klein Avenue (view south).

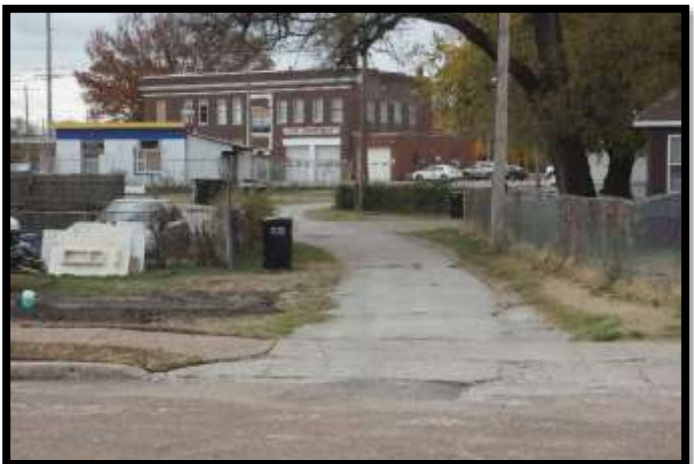
Photograph 6: Alley between Broadway and Oriole Street (view southwest).

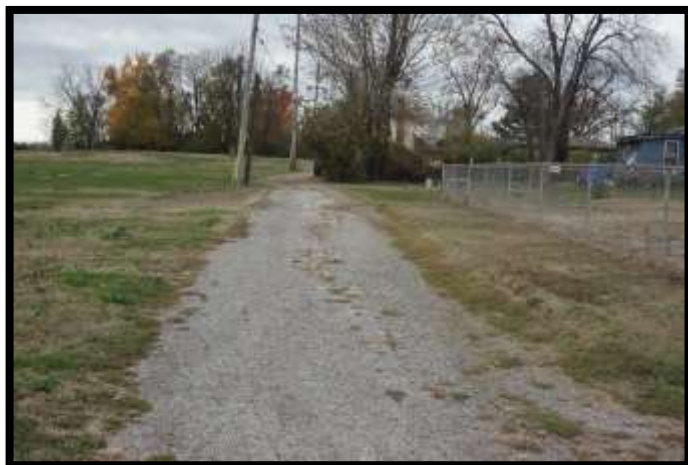
Photograph 7: Alley between Fillmore Avenue and Jefferson Street.

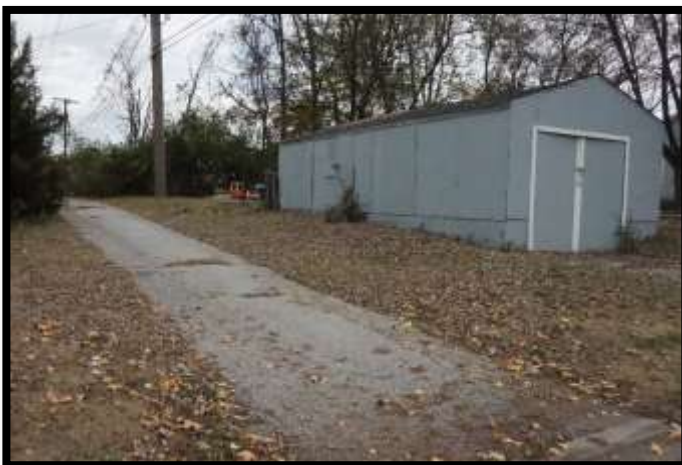
Photograph 8: Alley between Jefferson Street and Fillmore Street (view northeast from 6<sup>th</sup> Street).

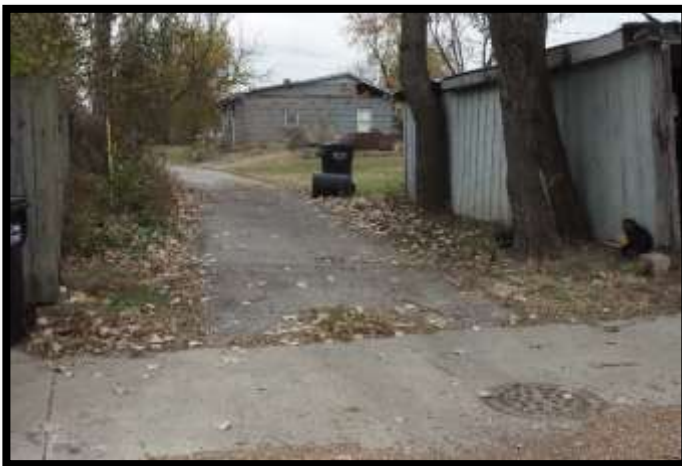
Photograph 10: Alley between Jefferson Street and Washington Street (view northeast from Klein Street).

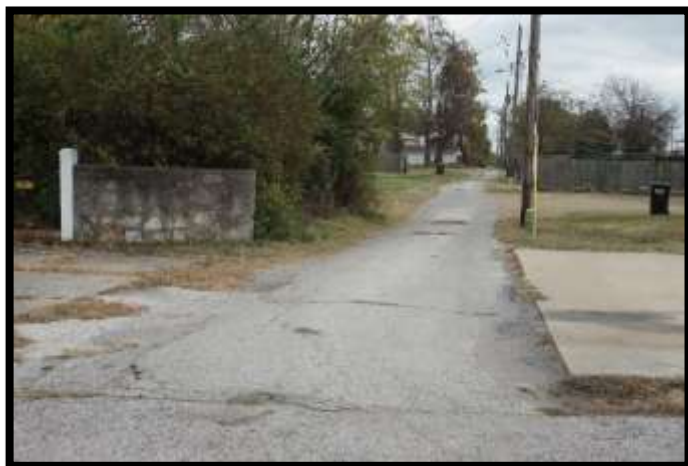
Photograph 11: Alley between Bissell Street and Market Street (view east from Baucum Street).

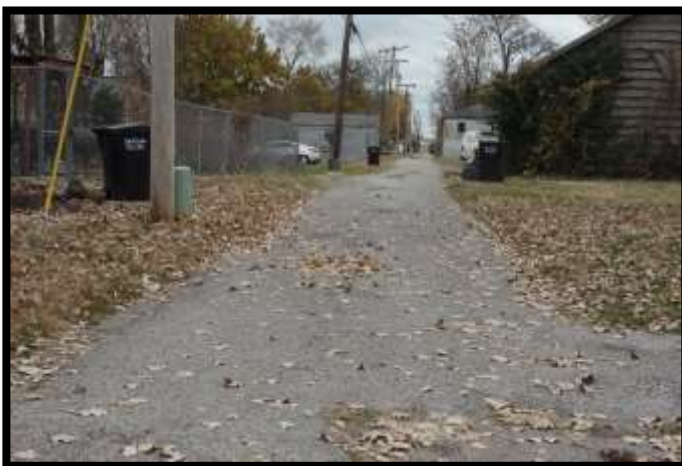
Photograph 12: Alley between Market Street and Logan Street (view east from Baucum Street).

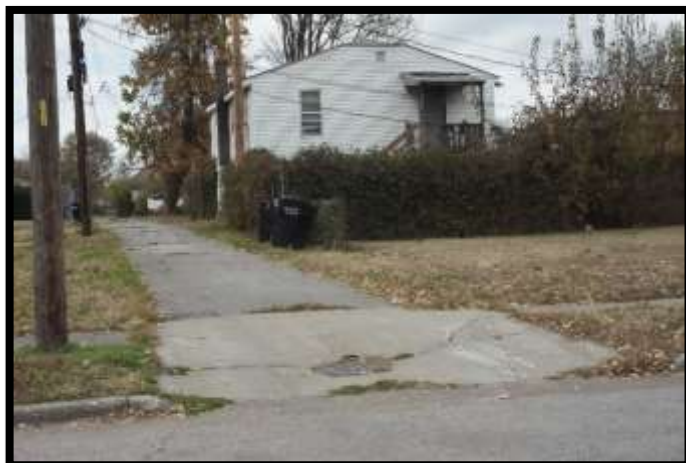
Photograph 13: Alley between Bissell Street and Market Street (view west from Meredocia Street).

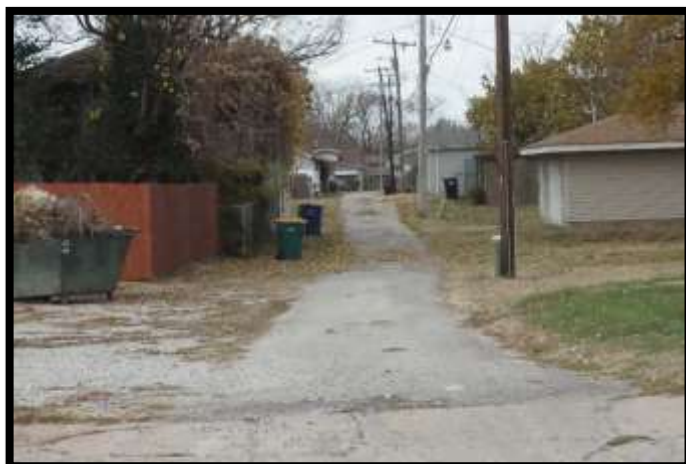
Photograph 15: Alley between Market Street and Logan Street (view west from Meredocia Street).

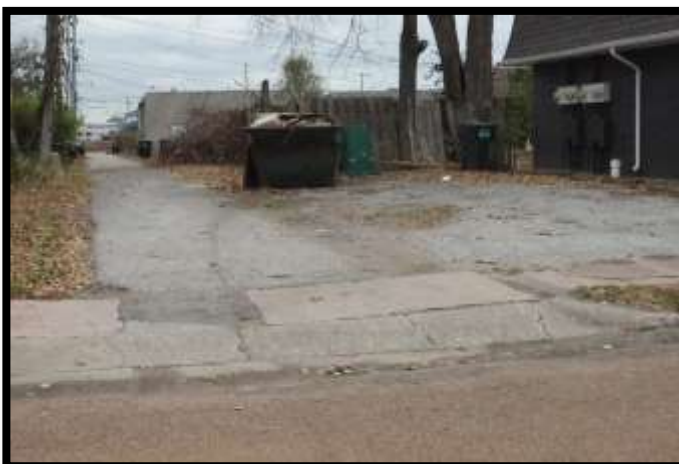
Photograph 16: Alley between Market Street and Logan Street (view east from Selb Street).

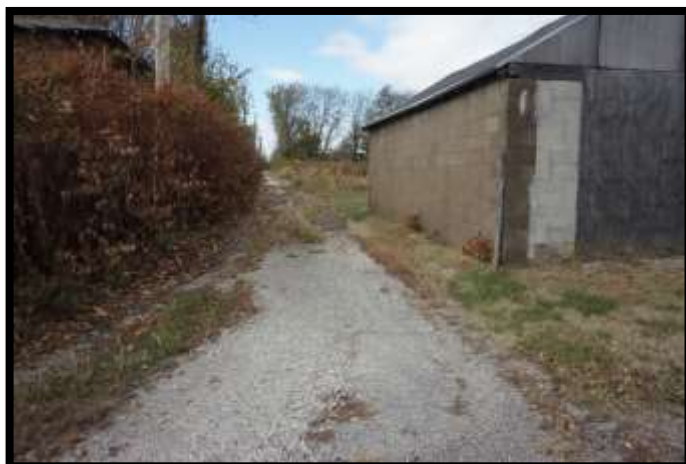
Photograph 17: Alley between Calhoun Street and Douglas Street (view west from Line Alley); several holes have been filled with asphalt since June 2010 inspection.

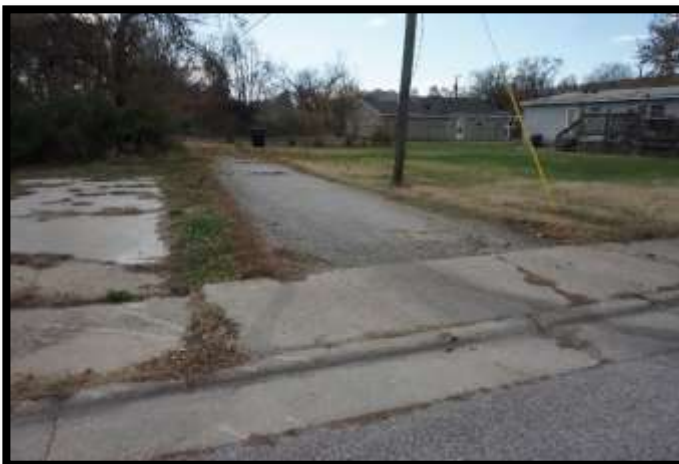
Photograph 18: Alley between Salveter Street and Meredocia Street (view south from Rogan Street).

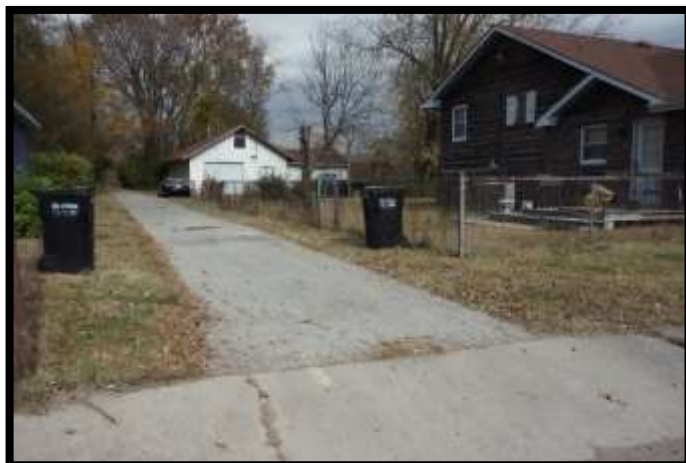
Photograph 19: Alley between Allen Street and Rogan Street (view north from Allen Street).

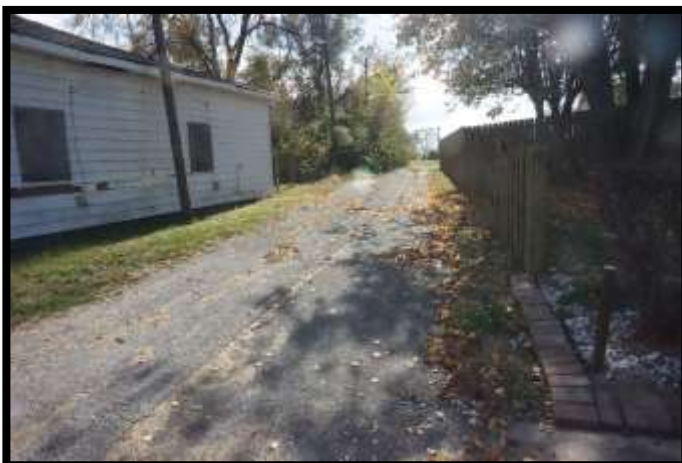
Photograph 20: Alley between Baucum Street and West 3<sup>rd</sup> Street (view north toward Madison Street and College Street).

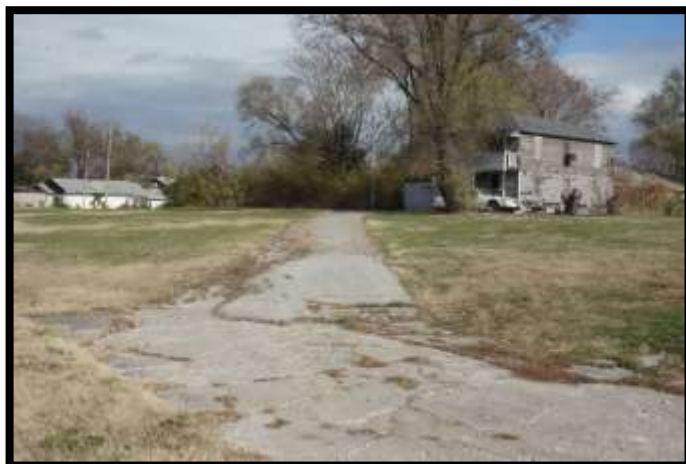
Photograph 21: Alley on Jackson Street (between 3<sup>rd</sup> Street and Baucum Street).

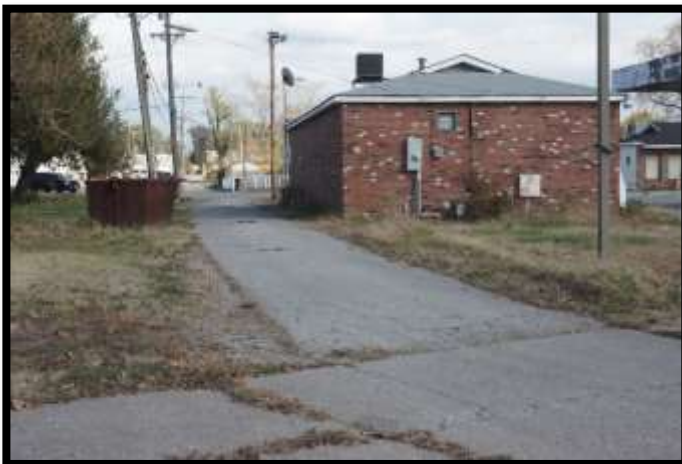
Photograph 22: Alley between 4<sup>th</sup> Street, Broadway, and Lincoln Avenue.

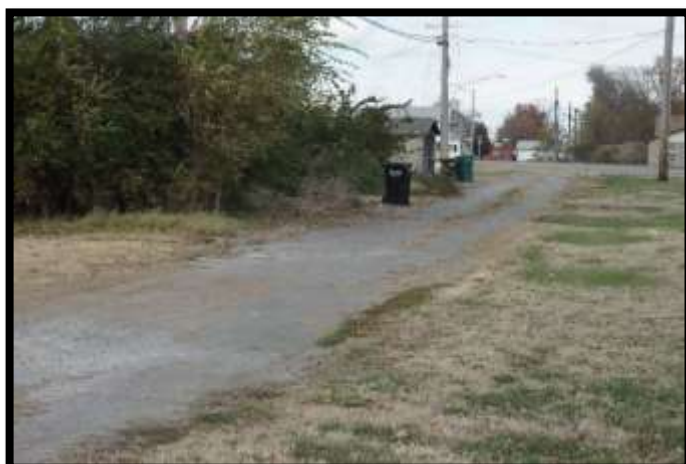
Photograph 23: Alley (gravel) between 3<sup>rd</sup> Street and 4<sup>th</sup> Street (view north from Abbott).

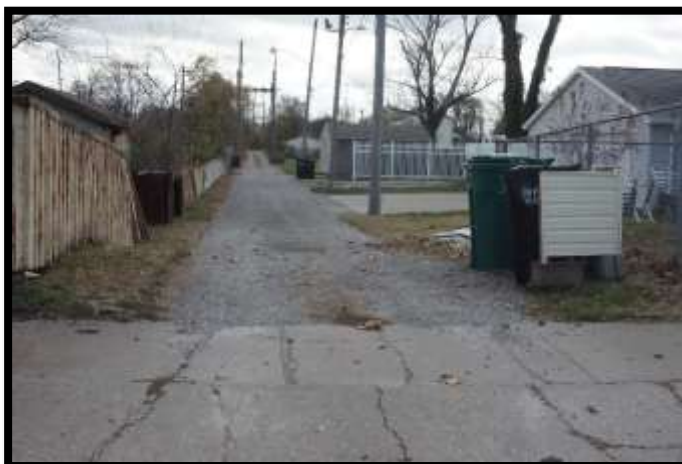
Photograph 24: Alley between 3<sup>rd</sup> Street and 4<sup>th</sup> Street (view south from Granville).

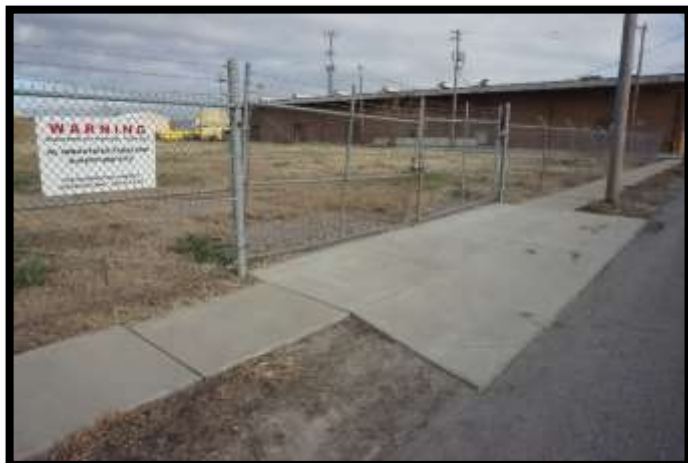
Photograph 1: Entrance to 1555 State Street property along State Street.

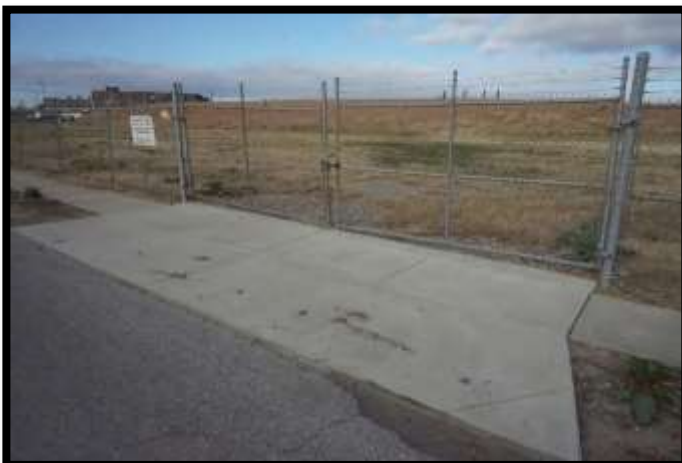
Photograph 2: Entrance to 1555 State Street property along State Street.

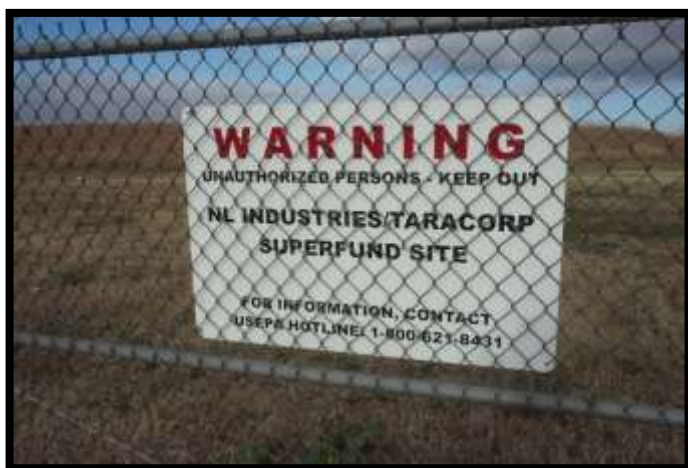
Photograph 3: Warning sign at front gate along State Street.

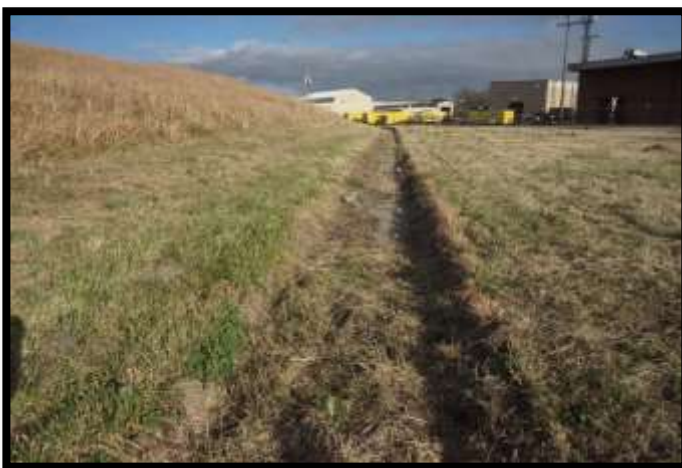
Photograph 4: Concrete drainage swale, east side of Taracorp pile (view north).

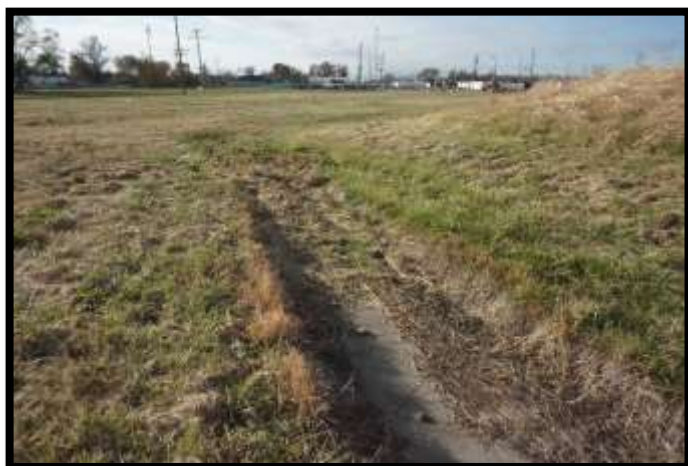
Photograph 5: End of concrete drainage of swale, east side of Taracorp pile.

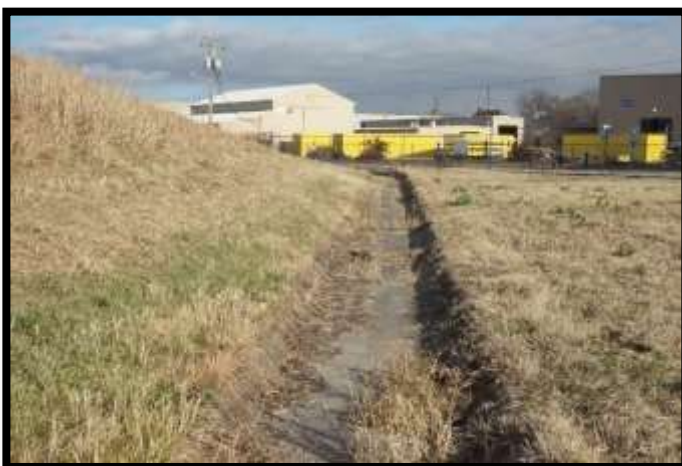
Photograph 6: Concrete drainage swale, east side of Taracorp pile (view north).

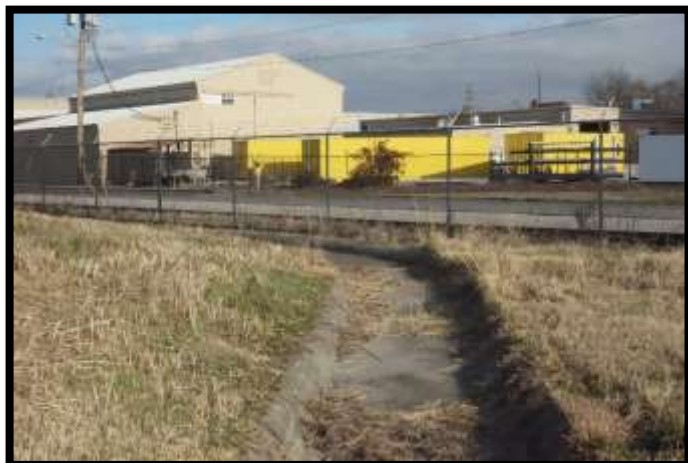
Photograph 7: Concrete drainage swale, east side of Taracorp pile (view north).

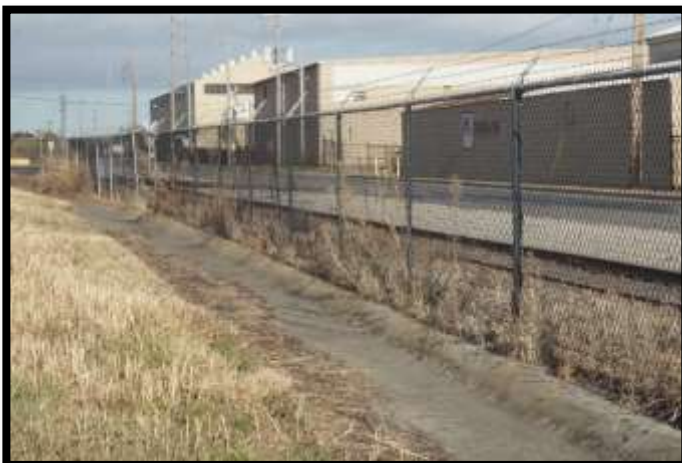
Photograph 8: Concrete drainage swale, east side of Taracorp pile (view north).

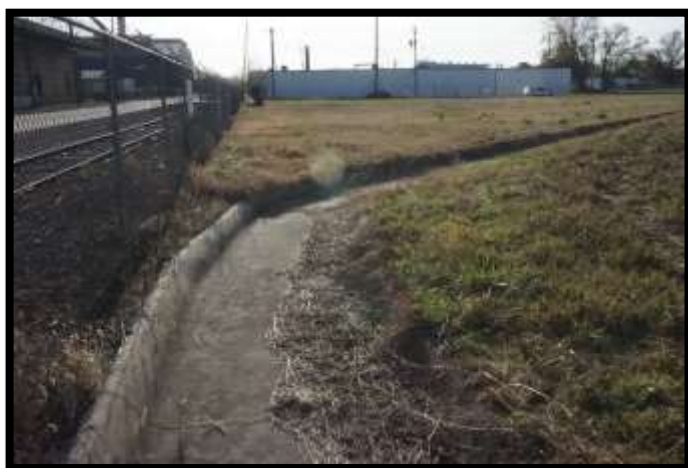
Photograph 9: Concrete drainage swale, north side of Taracorp pile (view southeast).

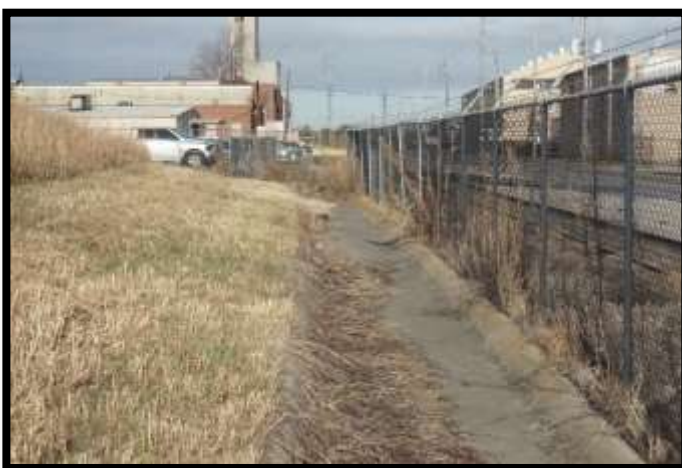
Photograph 10: Concrete drainage swale, fence, and vegetation; north side of Taracorp pile along 16<sup>th</sup> Street (view northwest).

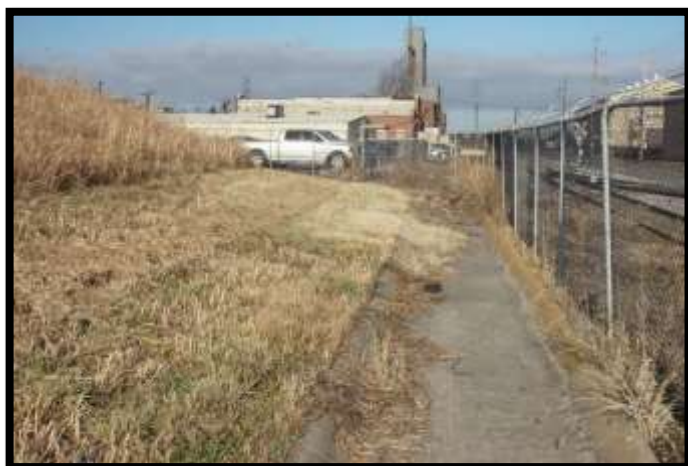
Photograph 11: Concrete drainage swale, fence, and vegetation; north side of Taracorp pile along 16<sup>th</sup> Street (view northwest).

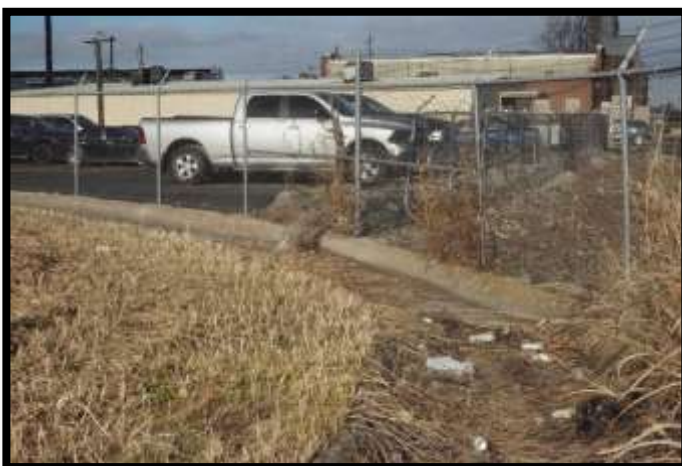
Photograph 12: Concrete drainage swale, fence, and vegetation; north side of Taracorp pile along 16<sup>th</sup> Street (view northwest).

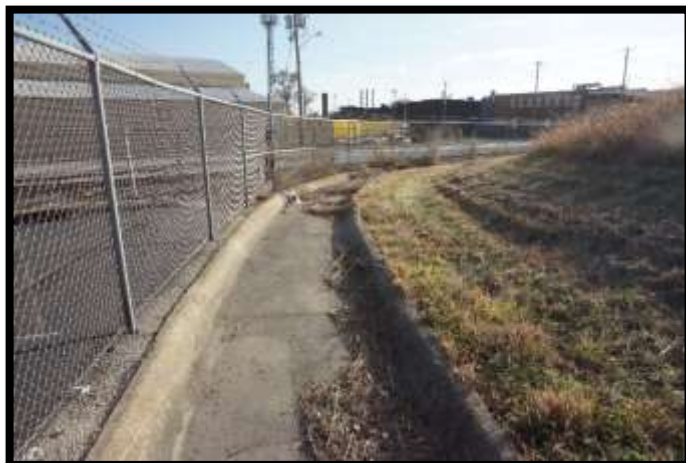
Photograph 13: Concrete drainage swale and vegetation; northwestern side of Taracorp pile (view northeast).

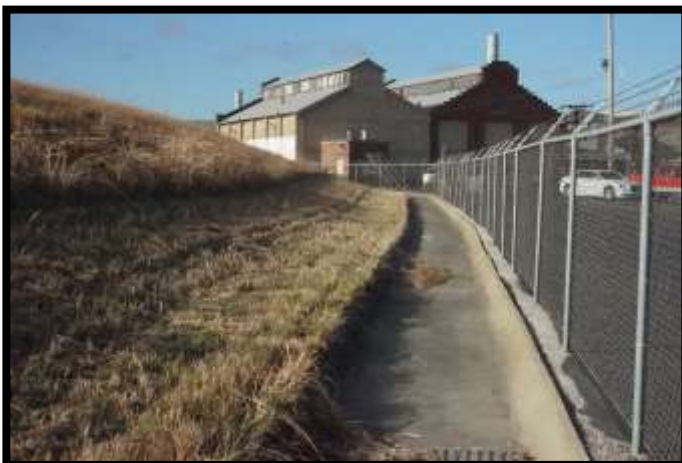
Photograph 14: Vegetation, northwestern side of Taracorp pile cap (view southwest).

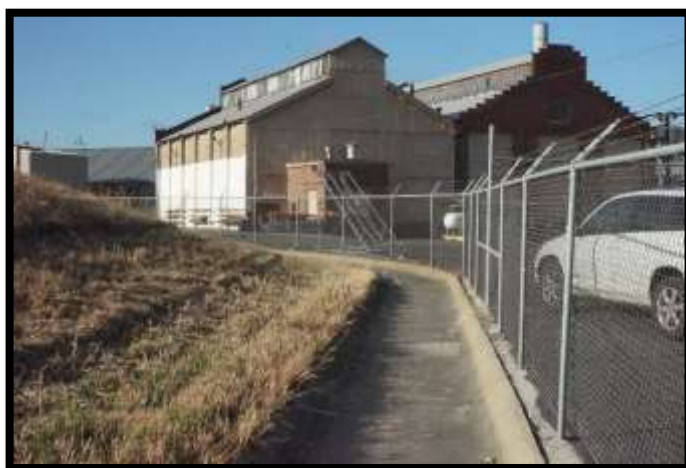
Photograph 15: Concrete drainage swale, fence, and vegetation along northwestern side of Taracorp pile (view southwest).

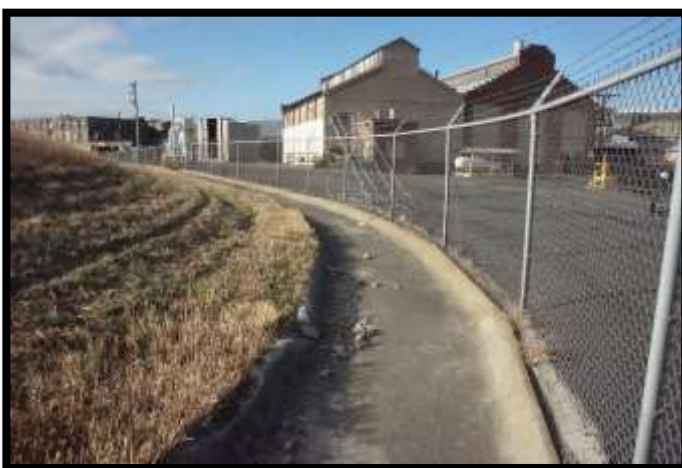
Photograph 17: Concrete drainage swale, fence, and vegetation along northwestern side of Taracorp pile (view southwest).

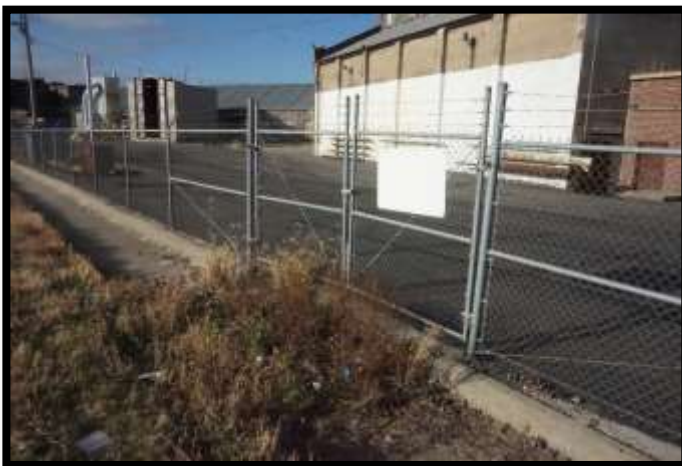
Photograph 18: Concrete drainage swale, fence, and vegetation along northwestern side of Taracorp pile (view southwest).

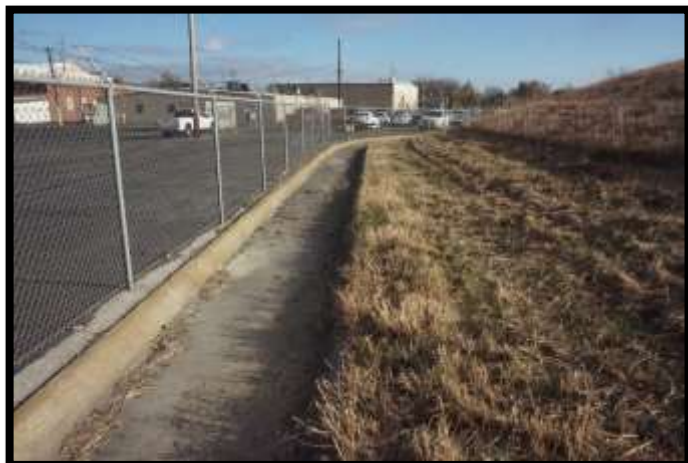
Photograph 19: Concrete drainage swale, vegetation along northwestern side of Taracorp pile (view north/northeast).

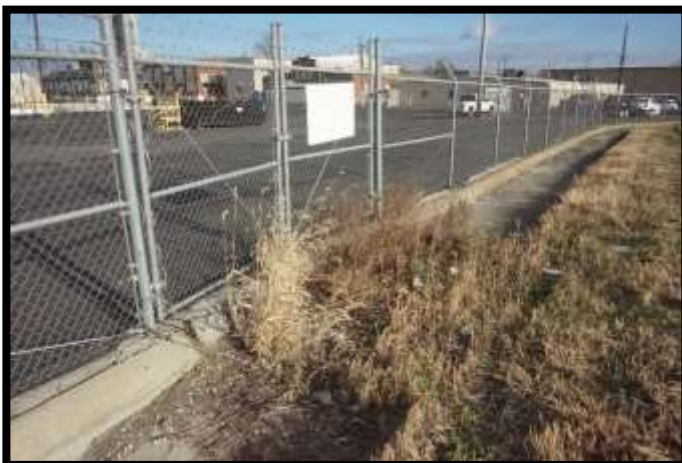
Photograph 20: Fence, warning sign, western side of Taracorp pile.
